## Sienna Construction Note 9/15/09

### Receiver Modification – Rev A boards

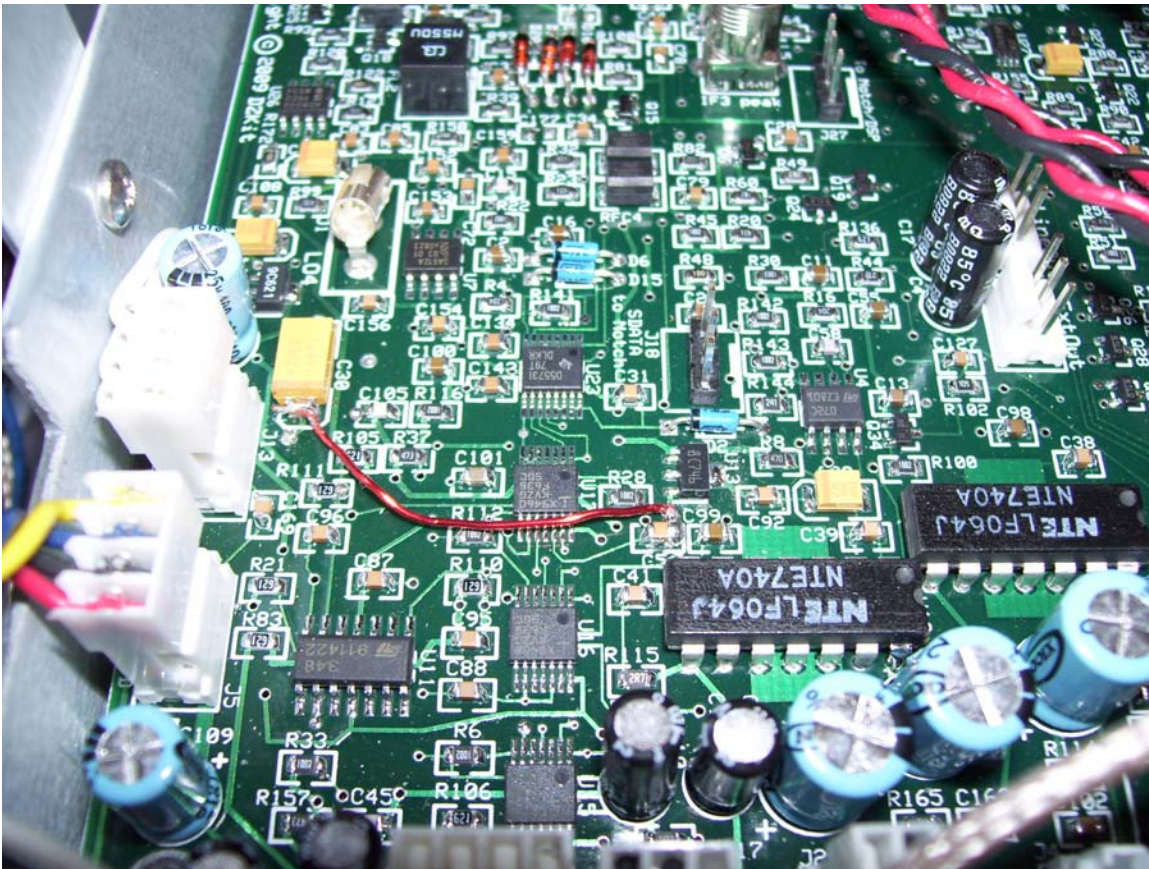
1. The output of the 9V regulator, U31, is not connected to the power plane. To fix this, add a short wire between the positive side of tantalum electrolytic capacitor C30 and the hole located to the right of U13, immediately below the text “C99”. See photo below. Use a spare piece of magnet wire or other insulated wire, being careful not to short the wire to any components.
